NASA CR-1949

**FABRICATION AND TEST OF
A SPACE POWER BOILER FEED
ELECTROMAGNETIC PUMP**

I - Design and Manufacture of Pump

*Prepared by
GENERAL ELECTRIC COMPANY
Cincinnati, Ohio 45215
for Lewis Research Center*

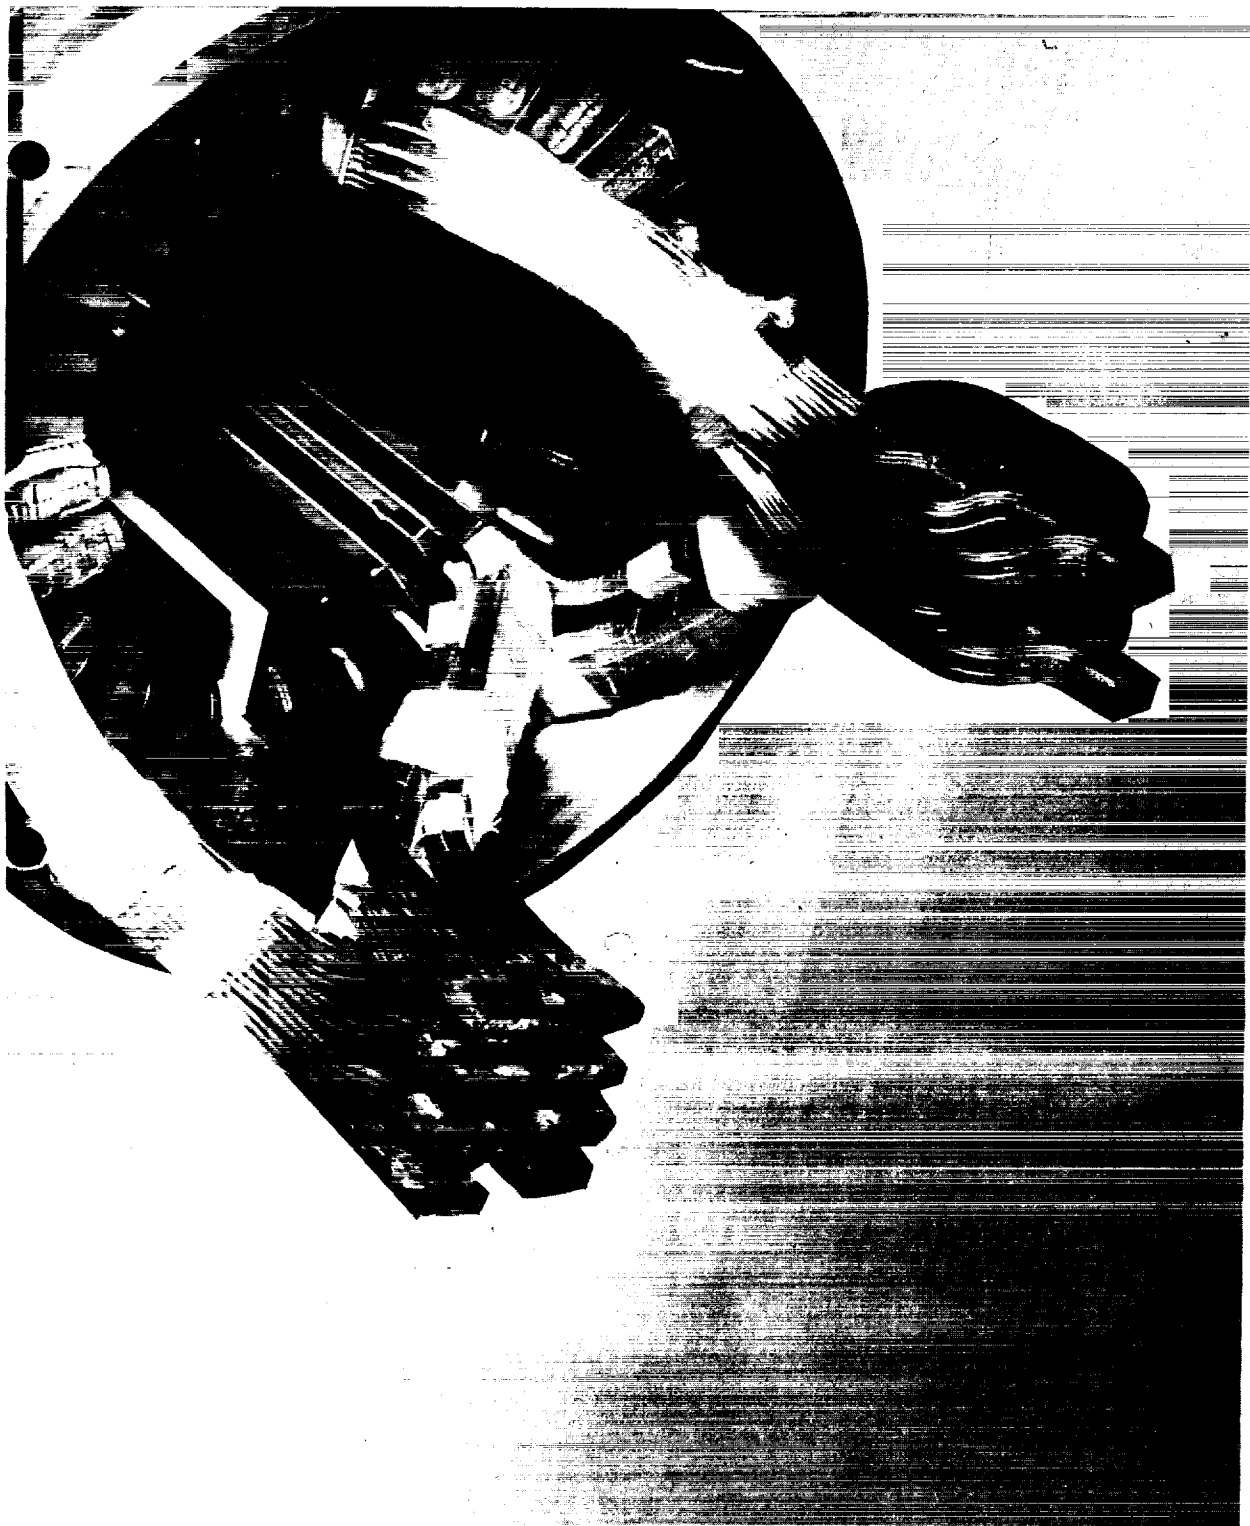
Figure 6. Trial Stator Coils, Made of Copper, Used for Evaluating the Feasibility of Using Full Coils in the Pump.

Based on the results noted above, the choice of half coil construction was mandatory. Implementing the use of half coil construction involved refining the upper and lower coil side geometries, selecting suitable turn and coil connection configurations, and developing the winding assembly procedure.

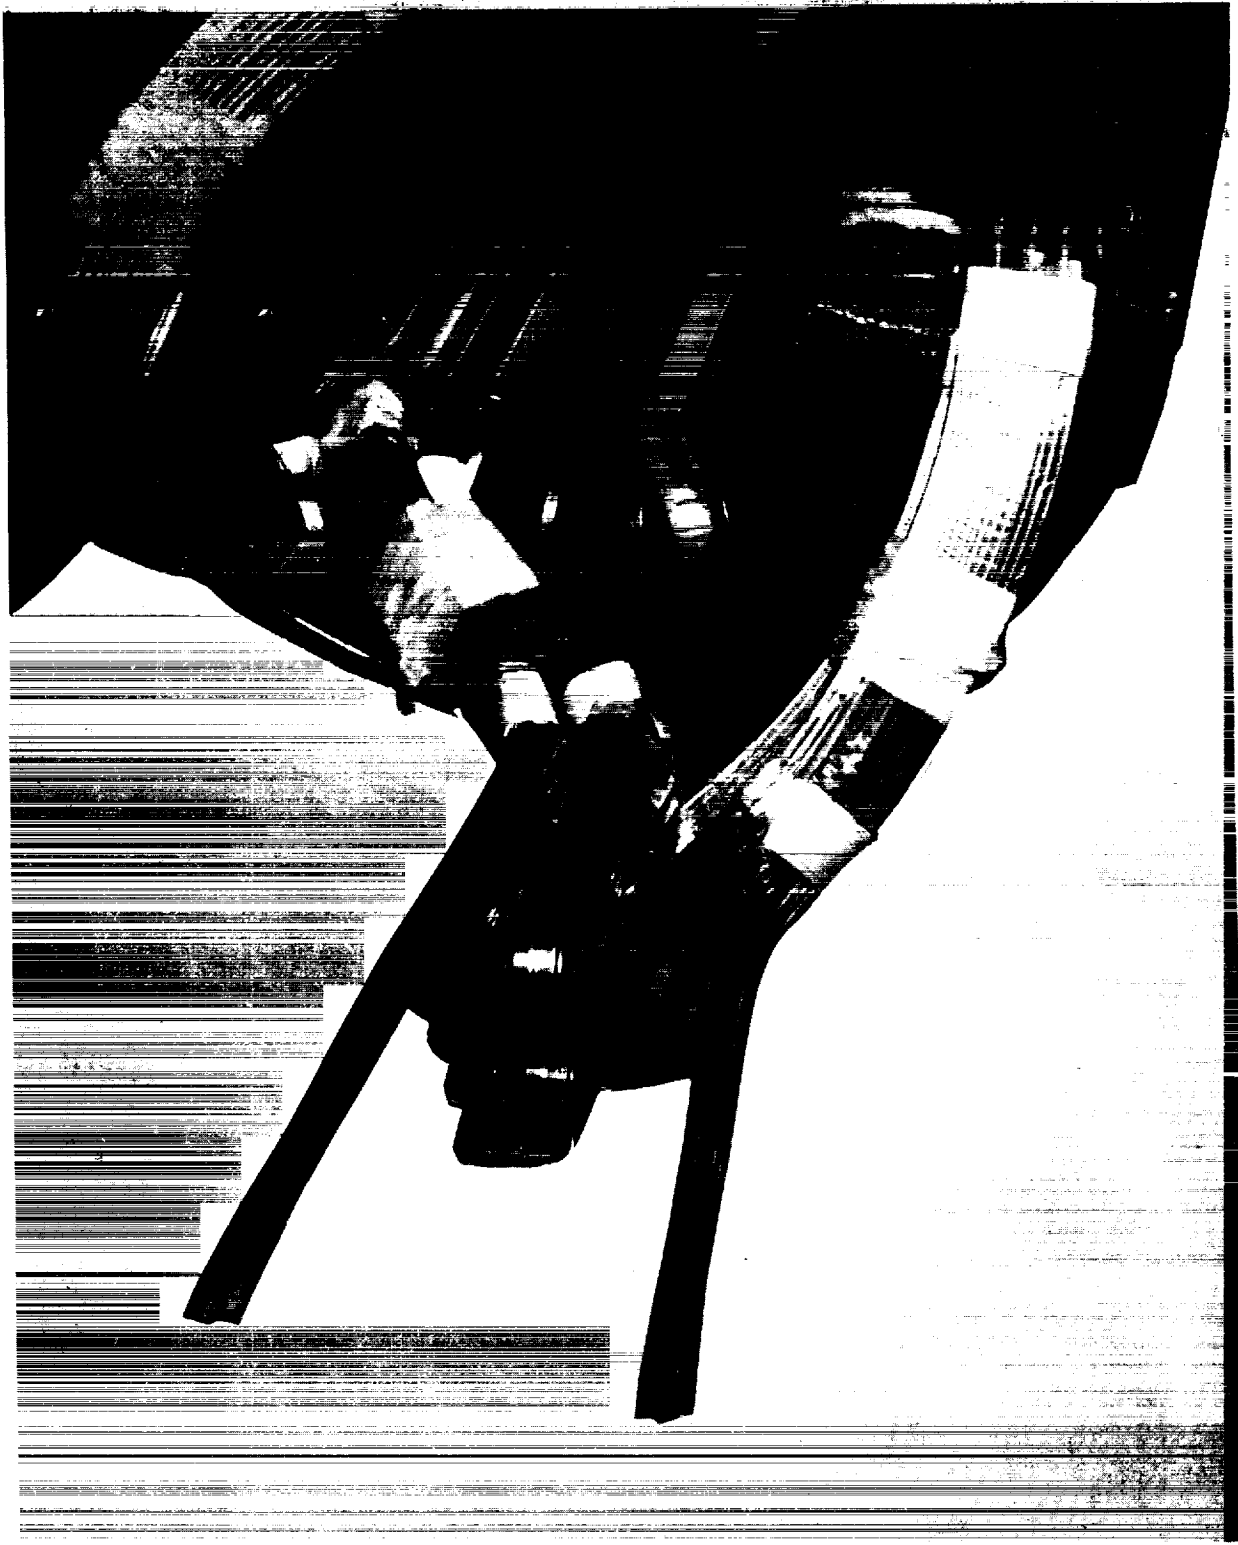
Figure 7. Model Stator for EM Pump with Trial Bar Windings and End Connections, on End Opposite Leads.

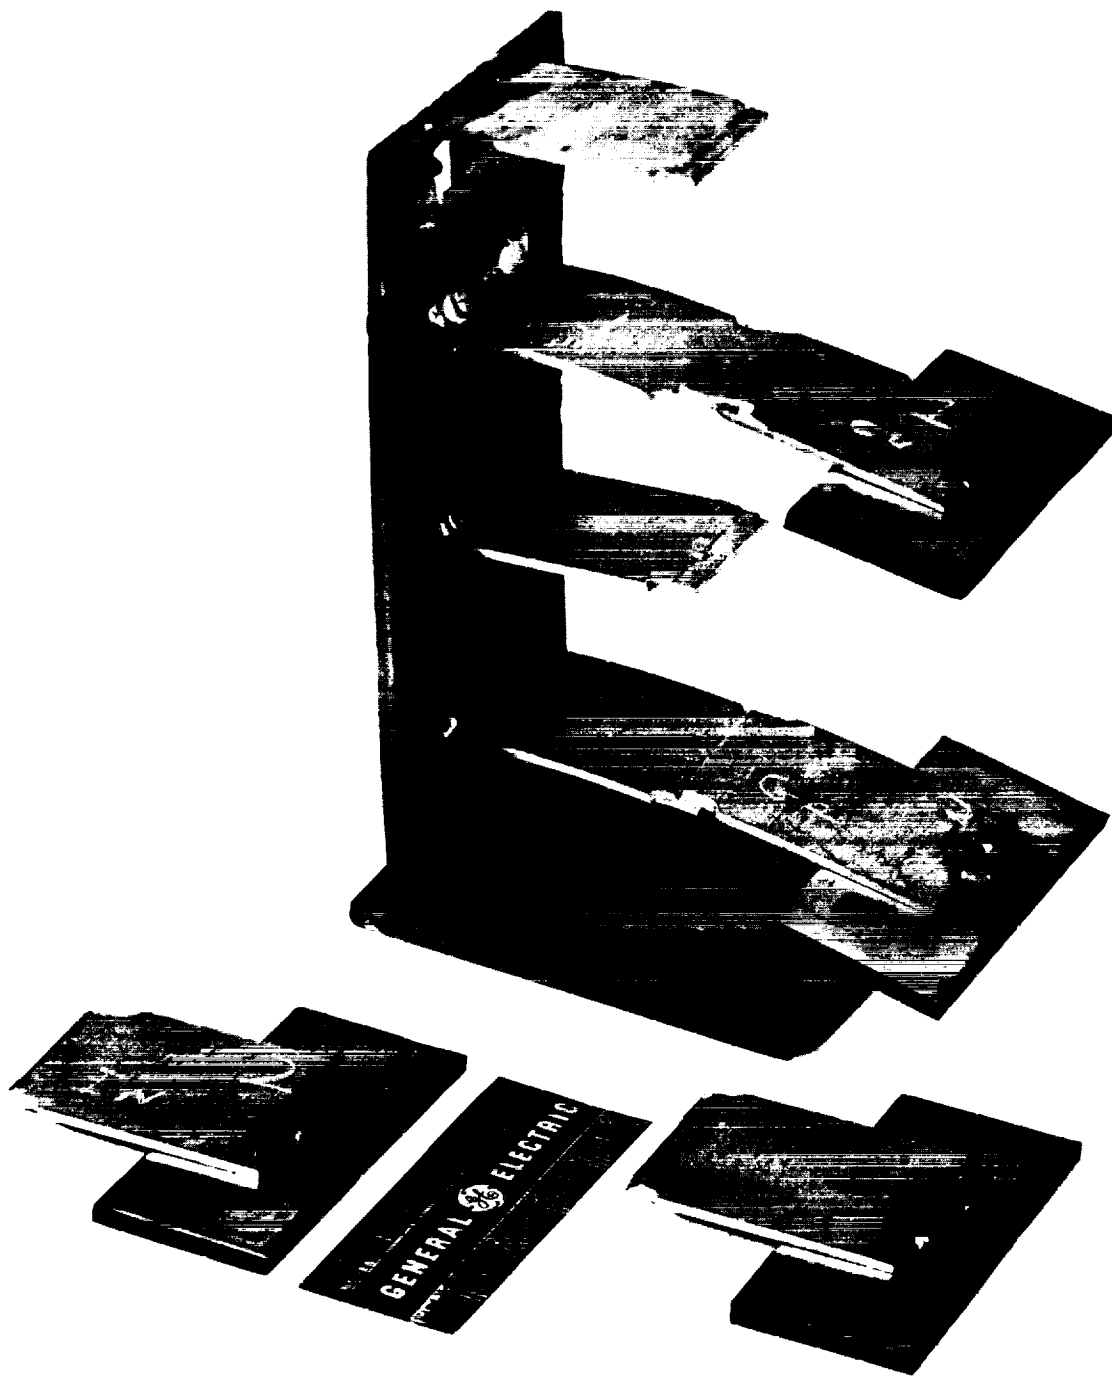
Figure 30. Results from Test to Check Strength of Joints Brazed with Different Alloys, with those of In Alloy Having Failed Between 1475° F and 1500° F.

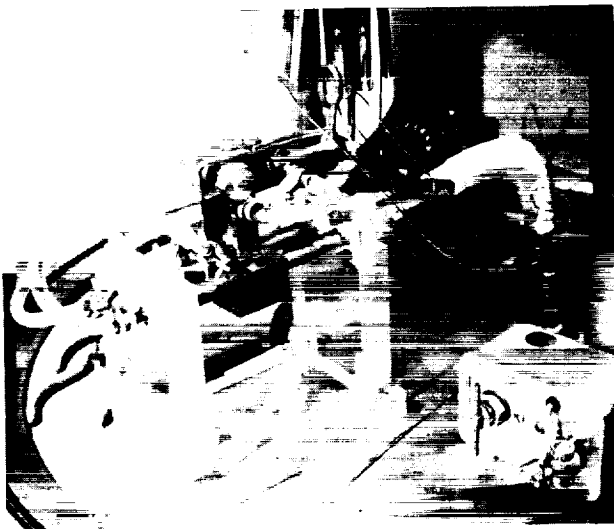
Close-up View of Induction Heating Coil and Adjustable Support, with Power Leads from Potted Feed-Thru, O₂ Analyzer Detector at Right, and T/C Switch in Rear.

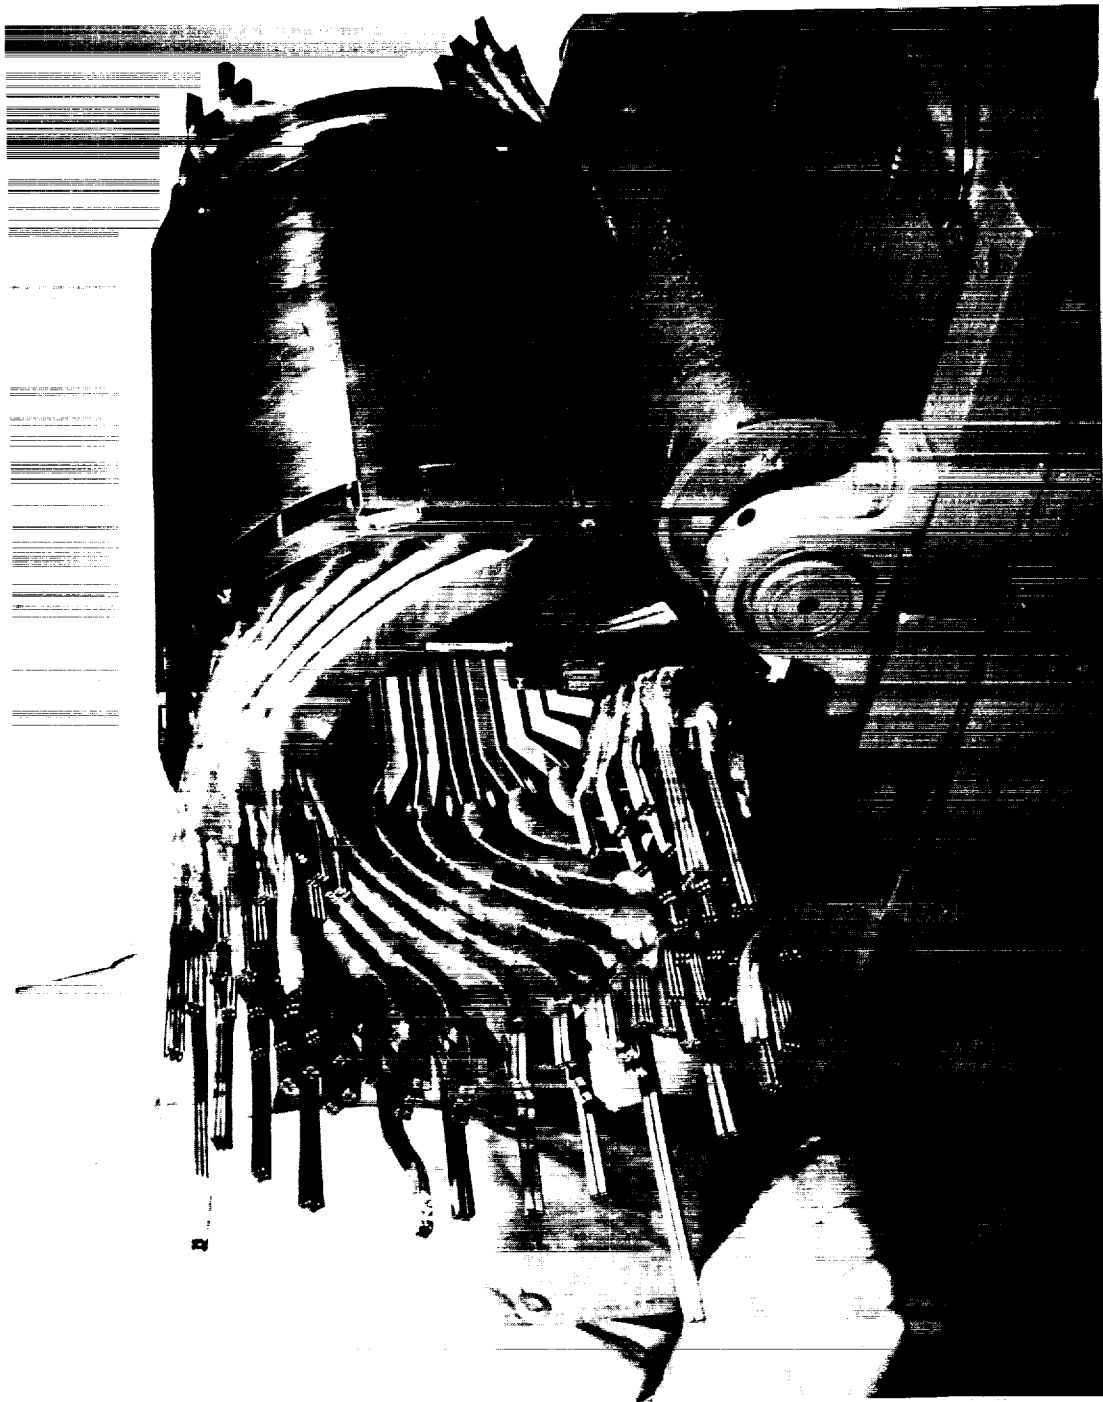
Figure 42. Coil Bars, or Sides, Being Inserted in Stator Iron Core, with Alumina Liners Visible in the Slots, and Coil Ends Covered with "S" Glass Tape.

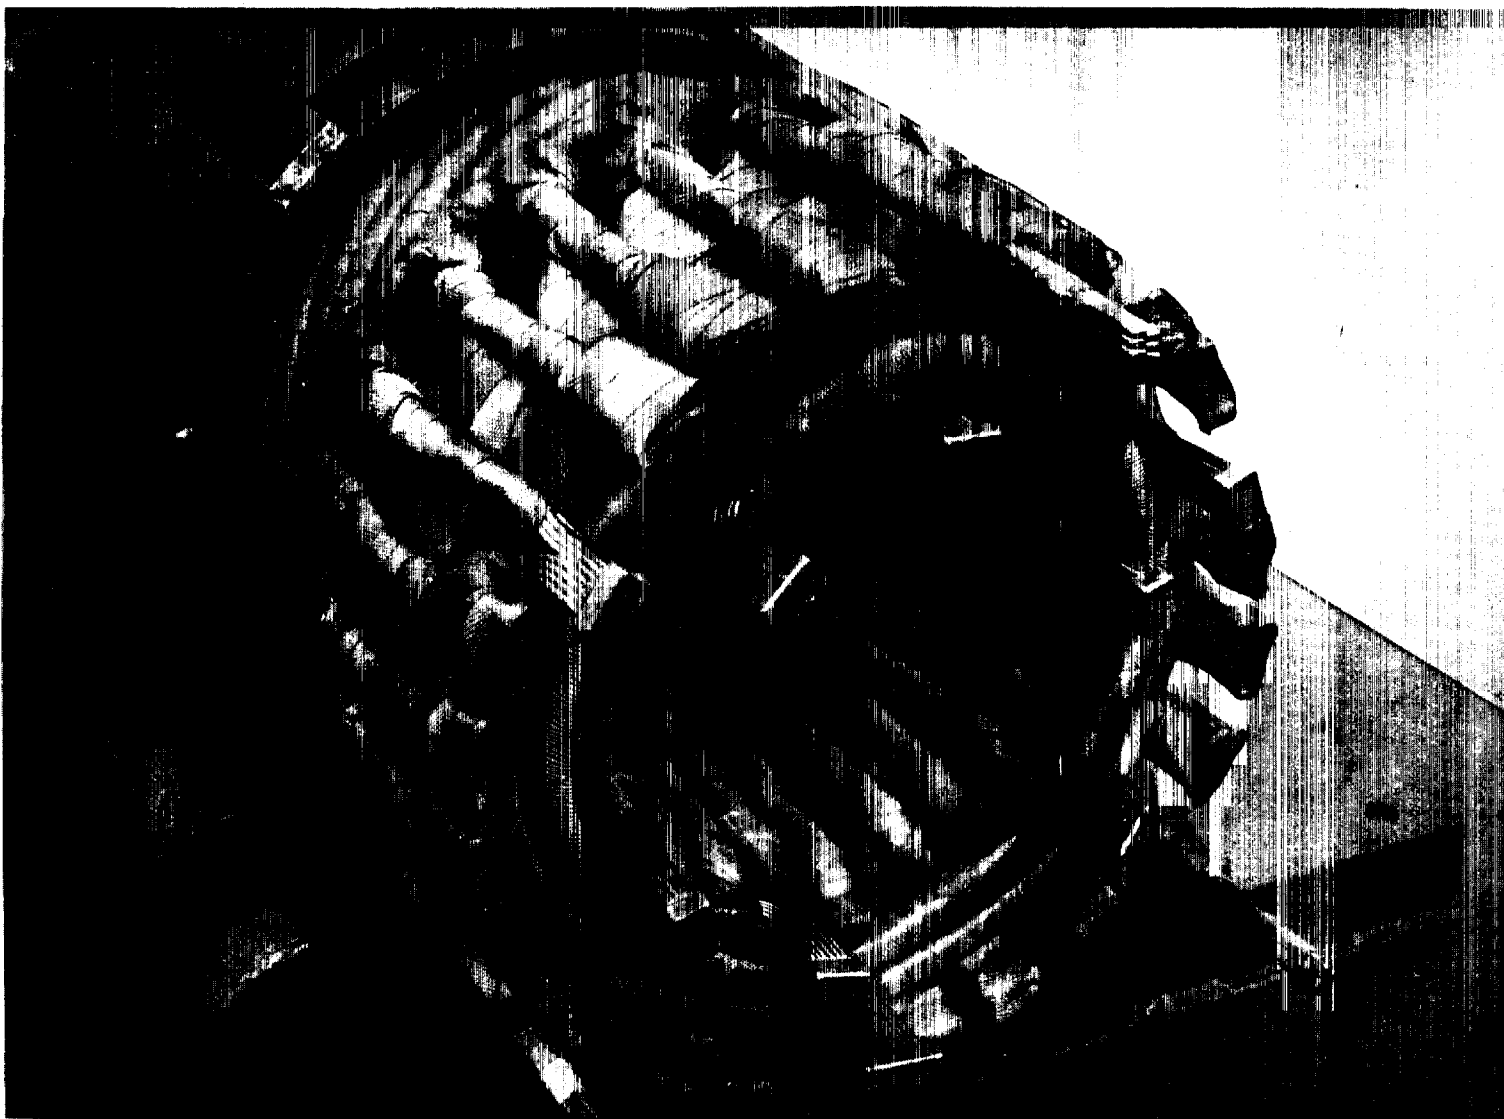
Figure 49. Coil Joints (Connection End of Stator) After Brazing and Final Insulation of Bar and Series Connections, with Pole-Phase and Wye Neutral Connections Brazed but not Insulated, and Line Connections Ready for Attachment to Lead Seal Jumpers in Final Assembly.

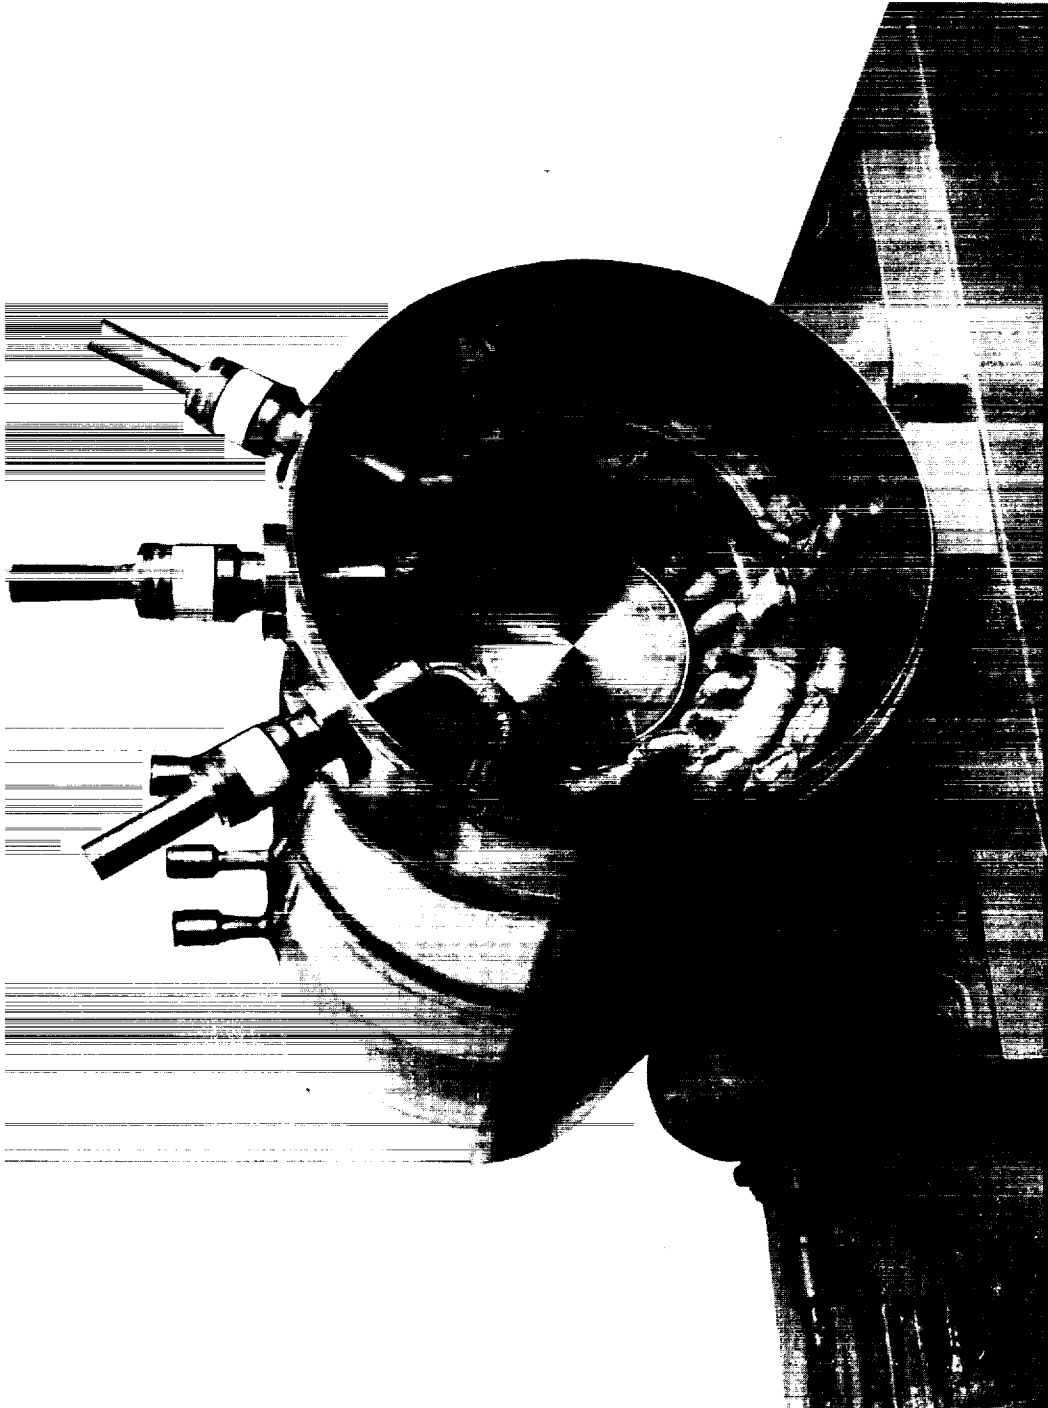
Figure 50. Assembled Stator Viewed from Connection End Prior to End Shield Attachment,
Showing Lead Seal Jumpers Brazed to Coils and Joints Taped.

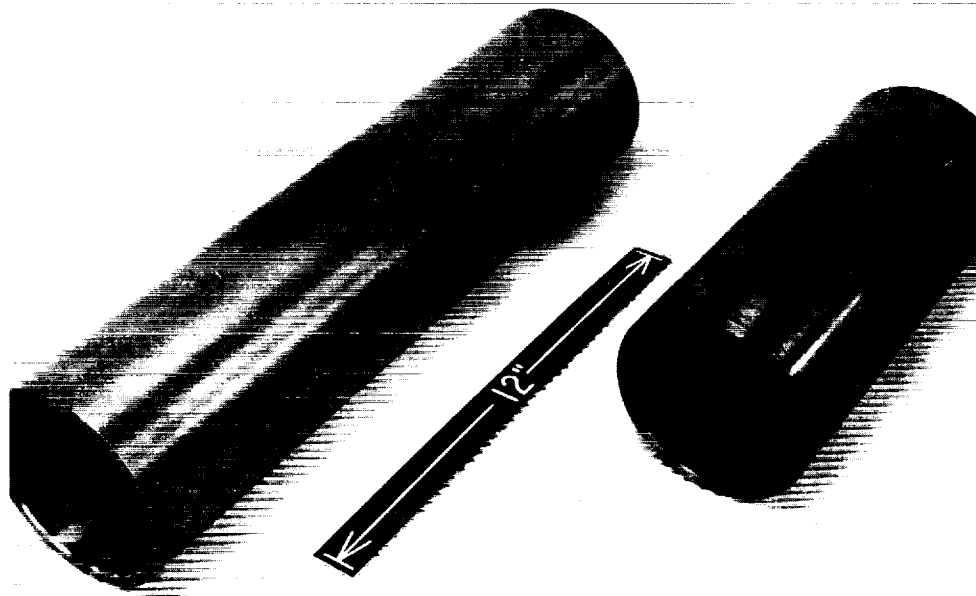
Figure 53. T-111 Alloy Tubes as Received from Vendor for use in Fabricating the Duct Wrapper and Wrapper Extension.

Photographs of the as-received tube hollows used for the pump wrapper and wrapper extension are shown in Figure 53, photographs of the hollows used for the helix and helix extension are shown in Figure 54. Vendor analysis of major T-111 alloy ingots are shown in Table 23. Analyses of all elements except for C, O, H, and N are considered the final product contents. Except as noted in Table 23, all ingots met the composition requirements.

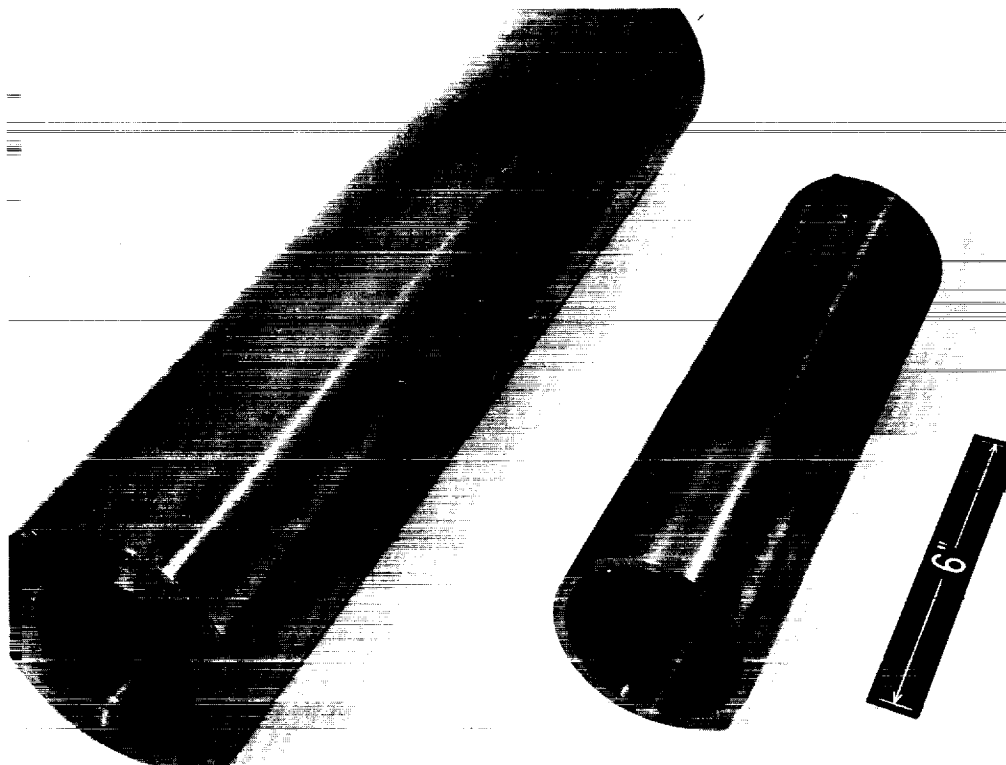
Figure 54. T-111 Alloy Tubes as Received from Vendor for use in Fabricating the Duct Helix (Left Hand Thick Walled Piece) and the Duct Extension.

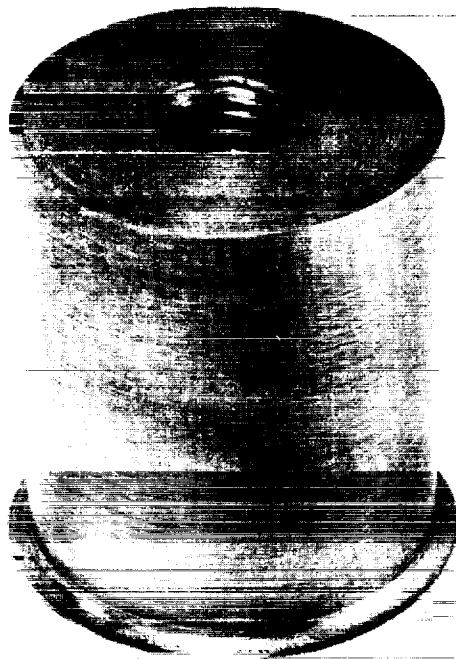
Figure 58. Trial Sample Transition (Bi-Metallic) Brazed Pipe Joint in Which Smaller Diameter Part is Nb-1Zr and Larger Diameter (Lower) Part is Type 321 Stainless Steel.

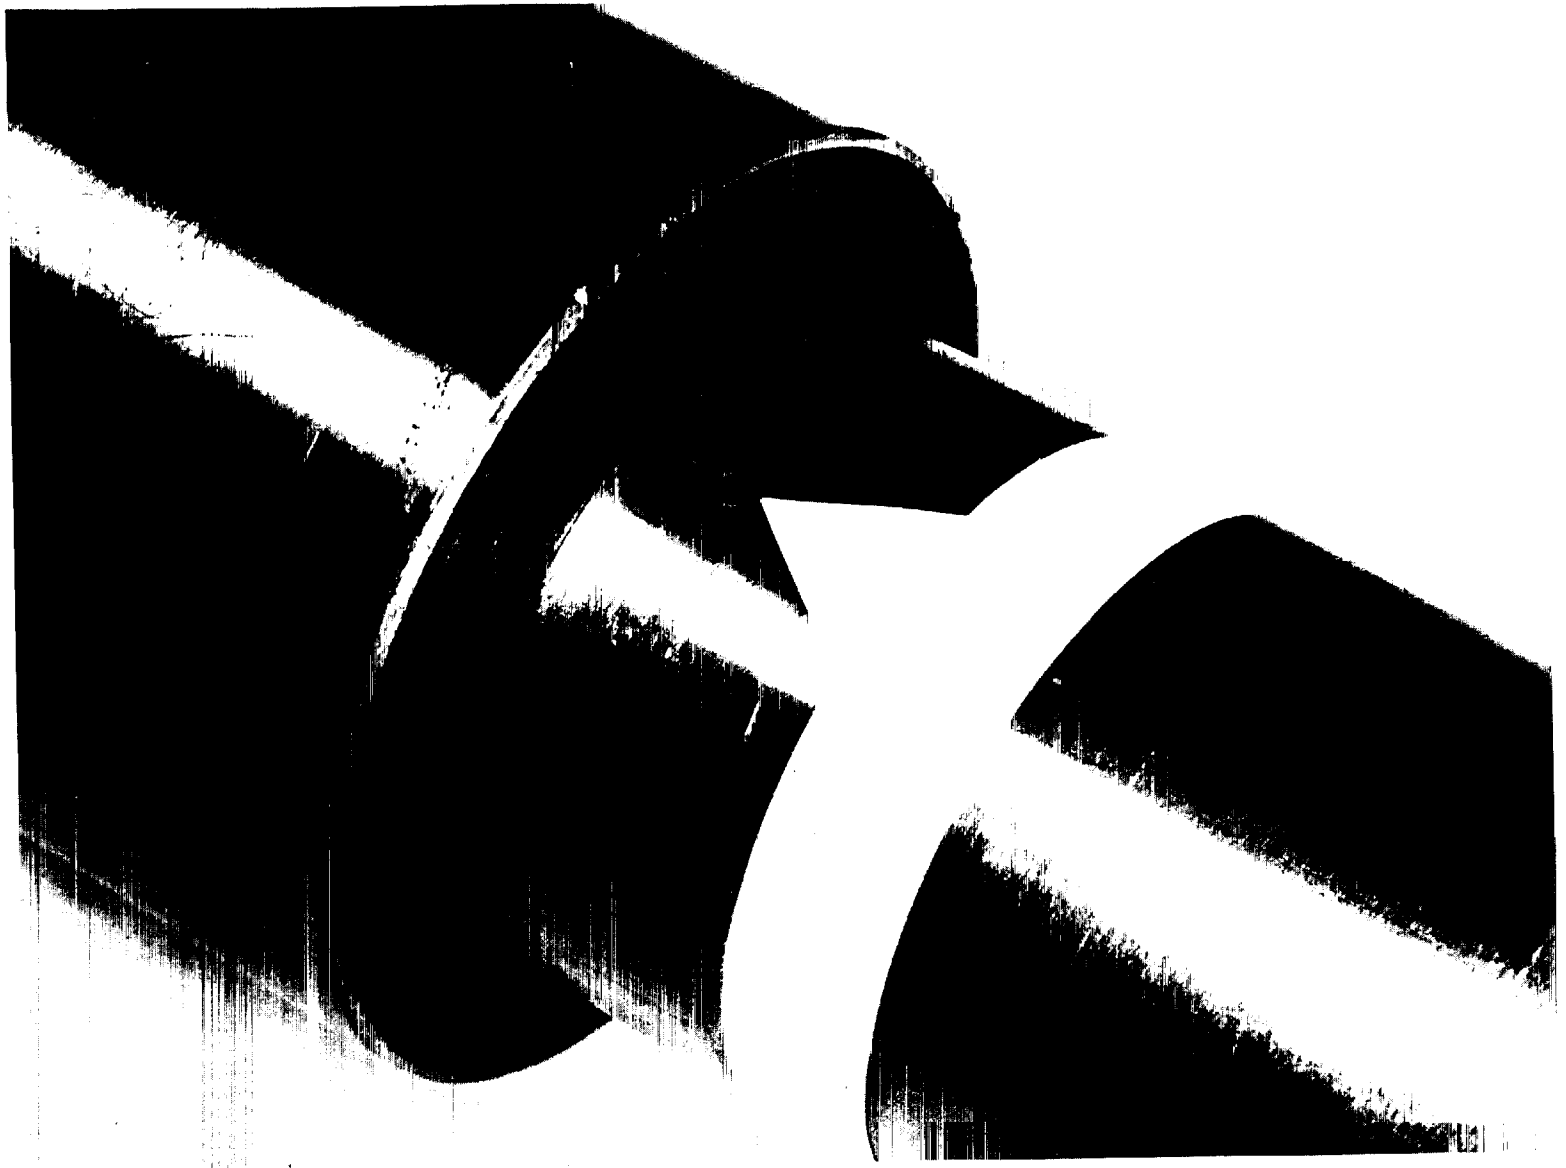
Figure 69. Close-up of T-111 Duct Helix Extension Showing Spot (Outlined by Scribed Circle) Where Small Leak was Detected Near Weld.

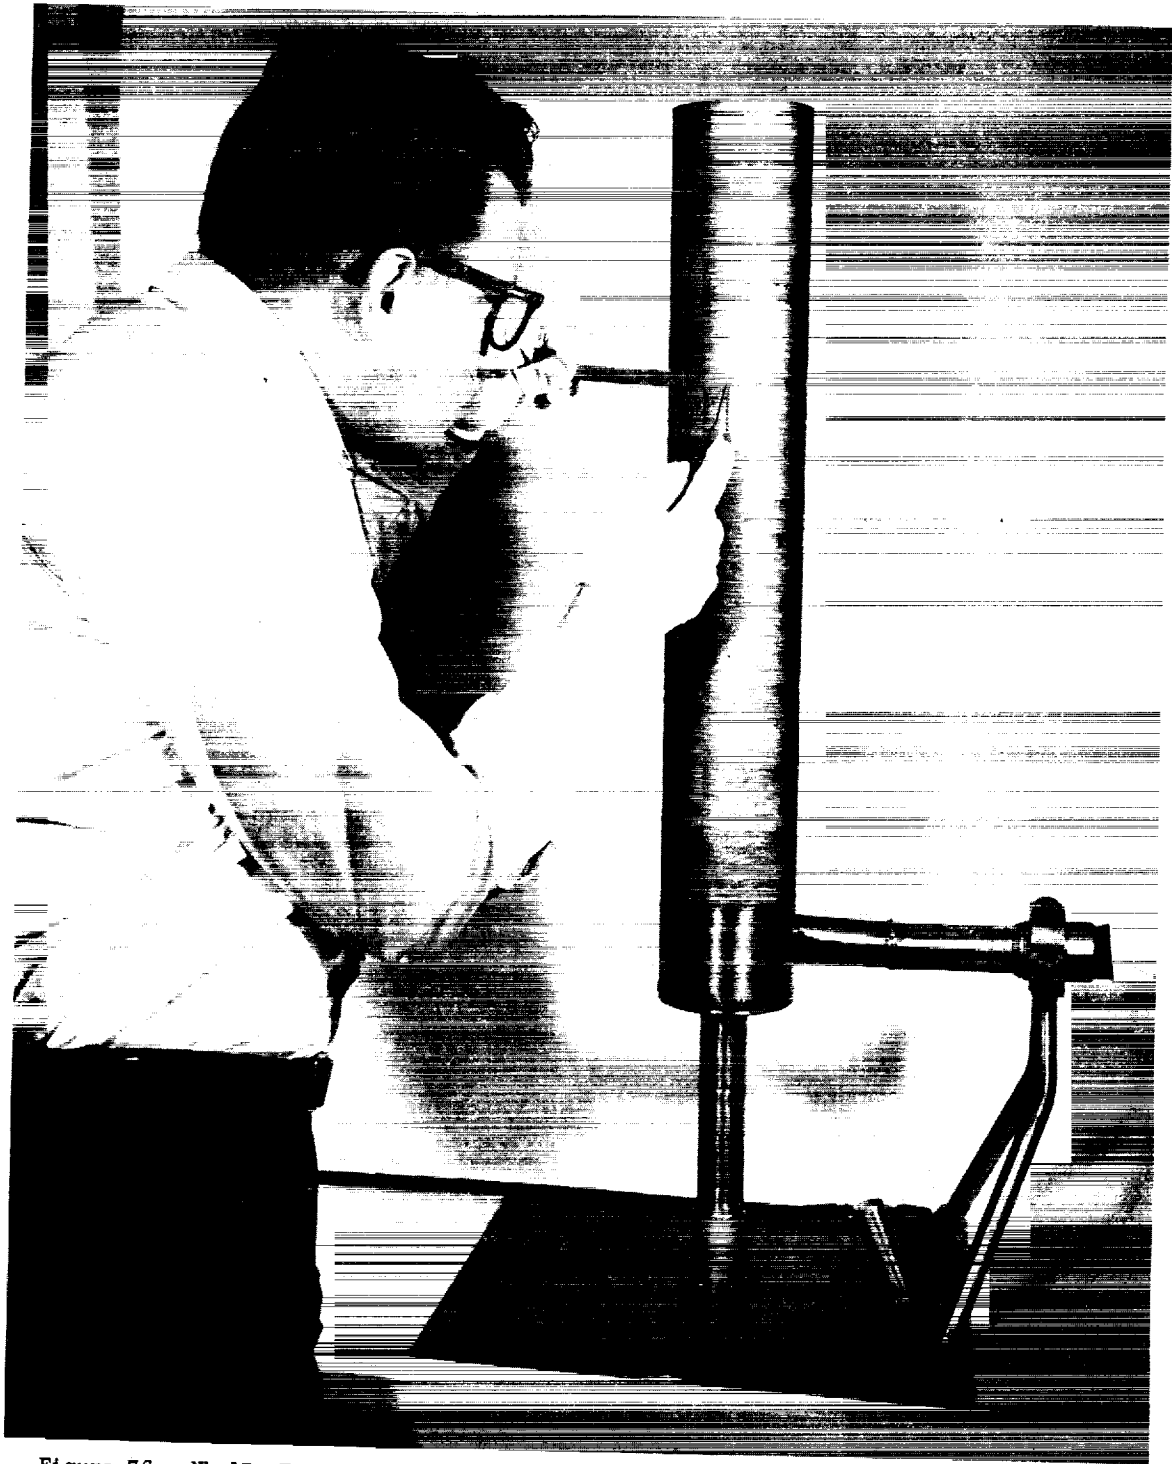
Figure 76. Nb-1Zr Foil, 0.002 Inch Thick, Being Applied in Strips to the T-111 Pump Duct to Provide a Total of 10 Layers for Thermal Insulation.

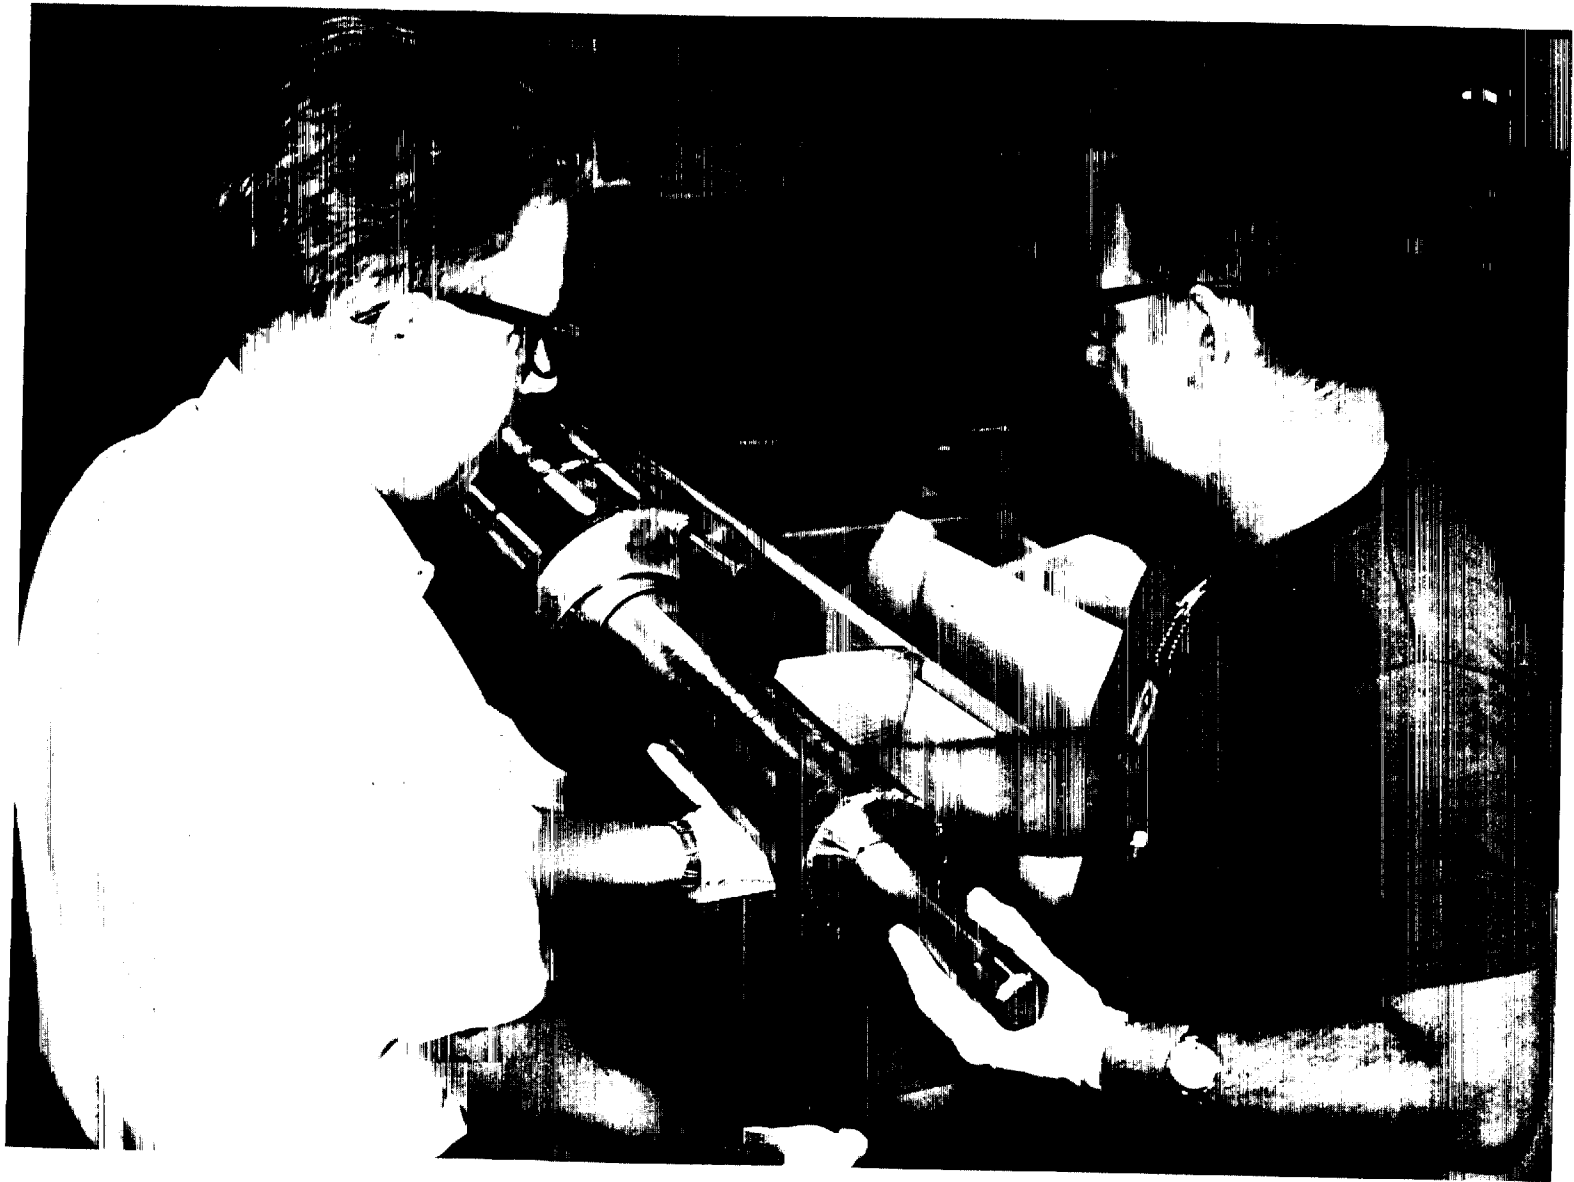
Figure 80. The "Trial" Mating of the Insulated Pump Duct into the Stator Bore Can to Check for Proper Clearance.
